The Permanent Solution For Rotten Posts

POST REPLACEMENT

step-by step guide

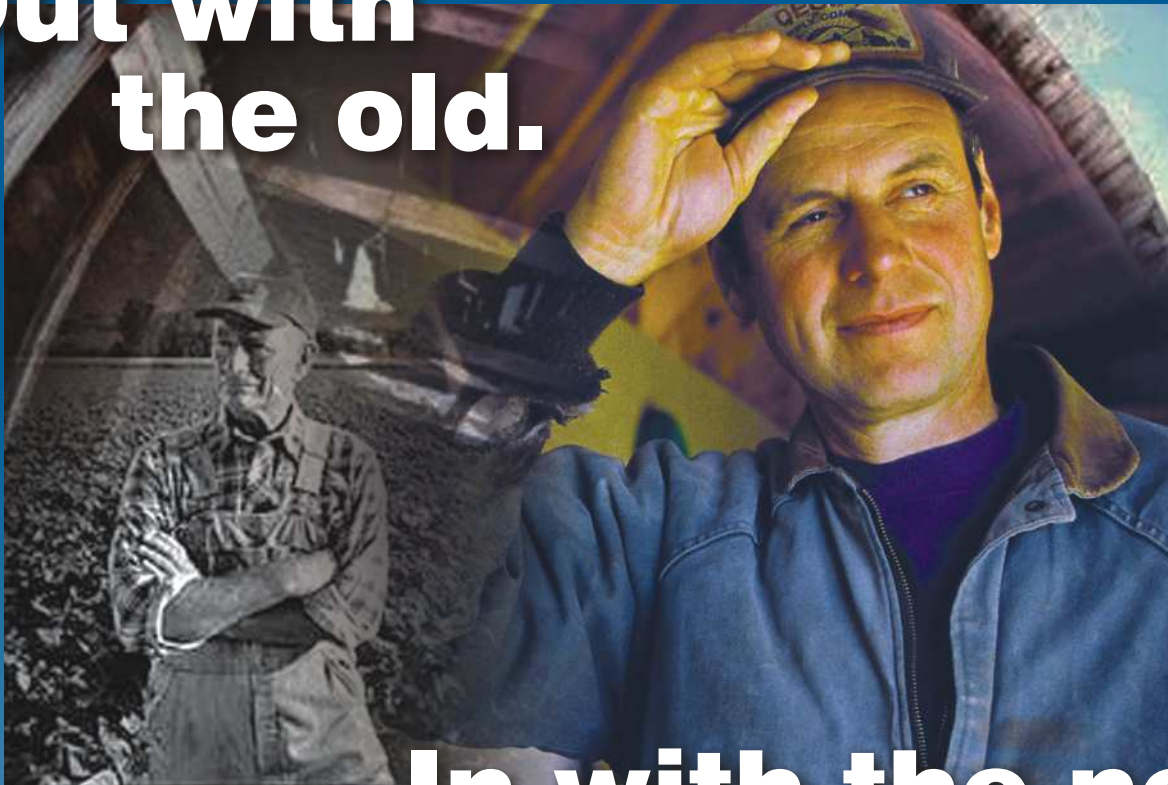
Out with the old.

In with the new!

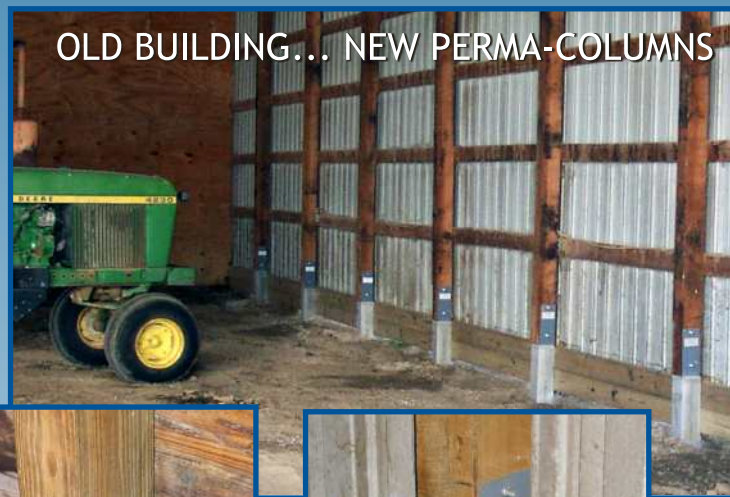
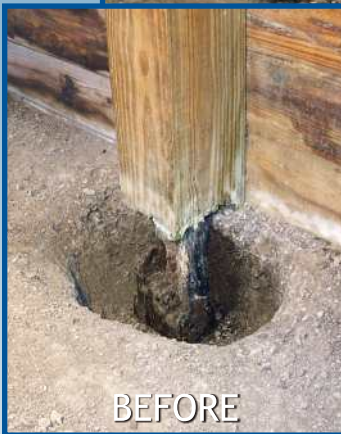
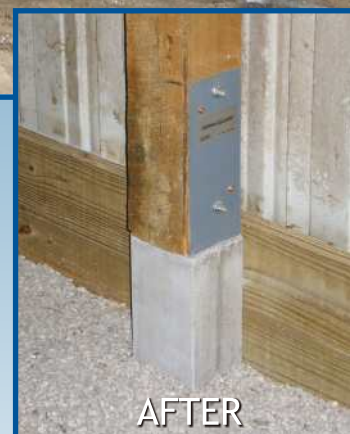
Introducing the new PERMA-COLUMN® PC6600. The same pre-cast technology available in new construction can now be used to repair rotten posts. Don't let deteriorated posts compromise a building with many useful years left in it! The PC6600 is a long awaited answer to an old and ongoing problem.

1. Locate rotten post to be replaced. Detach siding and remove existing skirt board.
2. Dig down next to face and sides of rotten post with auger.
3. Support truss with brace and hydraulic jack.
4. Cut rotten post off at ground level. No measuring necessary at this point.
5. Remove rotten portion of post.
6. Clean out post hole to provide a level, compacted base for the pre-cast concrete pad. Sakrete or ready mix concrete can also be used for post base.
7. Install pad and measure the Perma-Column for exact clearance needed. *Note: Perma-Column length may vary.
8. Mark existing post and cut to desired clearance for Perma-Column installation.
9. Install and position Perma-Column.
10. Install 1/4" x 3" wood lags. Drill and install (2) 1/2" bolts.
11. Reattach siding and skirt board.
